Treatment of Salt Attack and Rising Damp in Heritage Buildings in Penang, Malaysia

*A Ghafar Ahmad and Haris Fadzilah Abdul Rahman

Keywords: Conservation, Building defects, Salt attack, Rising damp, Desalination

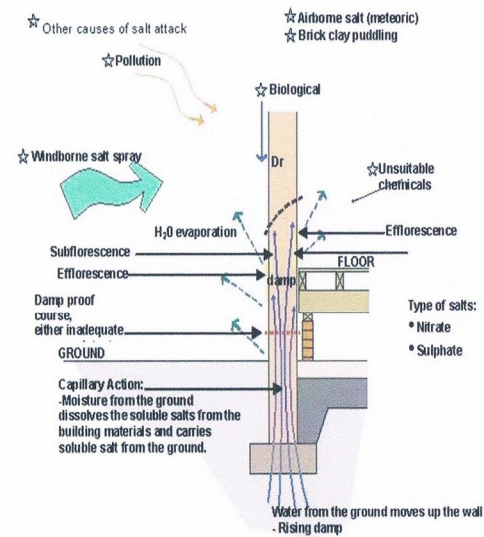
Figure 1. Causes of Salt Attack in Buildings

penetrates the surface and white powder is formed, this phenomenon is known as efflorescence and is harmless to the masonry (apart from creating an unsightly visual appearance). Salt may also attack by penetrating from below the surface; this is a more serious condition as the salt will become crystallised, a phenomenon known as sub-florescence. Pressure from the growth of the crystallisation process will cause building materials to crumble, resulting in serious damage to the buildings (see Figure 1).
